SUPA FLEX
Road Edge Guide Post

REPORT NO.: 1/122003 TESTING OF EXTRUDED FLEXIBLE uPVC GUIDE POSTS

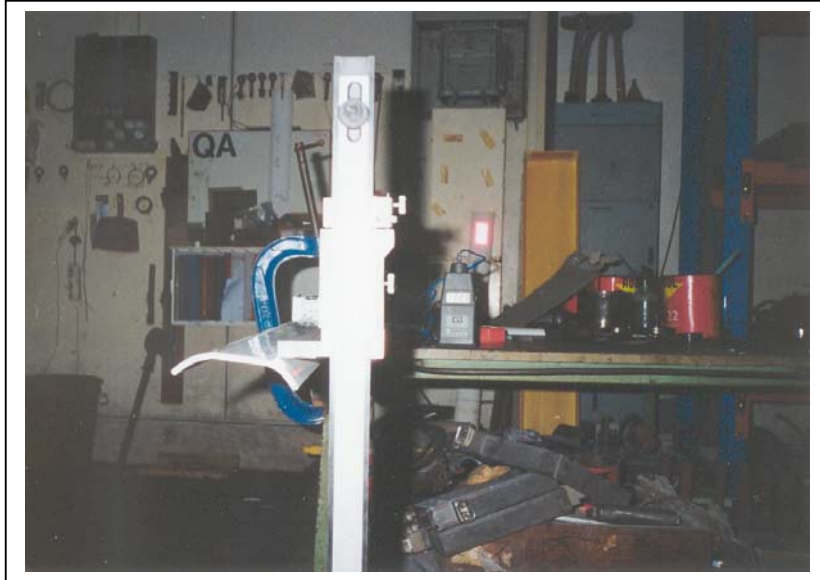
Photograph #1. Vernier Height Gauge at rest on sample post, ambient temp 23°C

Mitutoyo Vernier Height Gauge Cat. No 520-163 (Photograph #1)

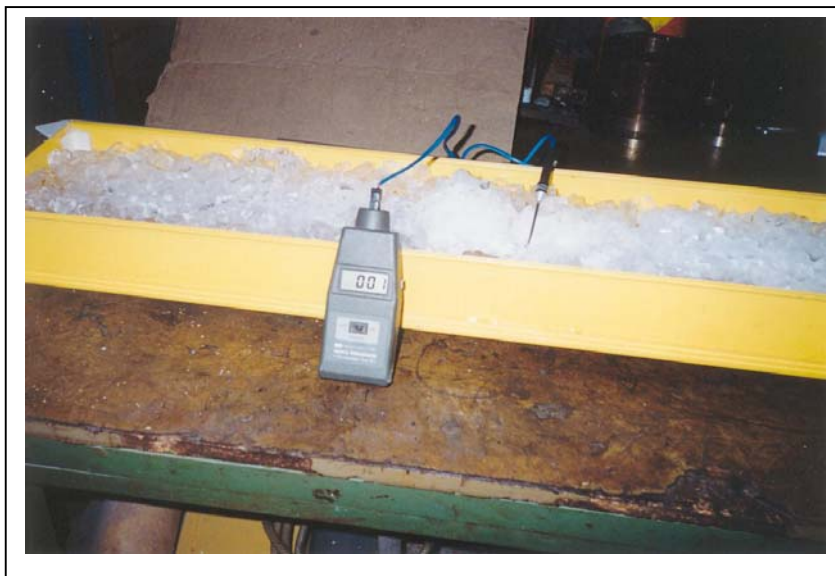
Photograph #2. Digital Thermometer / Ice Bath Unit

Lutron TM-901C Digital Thermometer with TP-02A probe (Photo #2)

Ice Bath 95 mm x 230 mm x 1700 (14 kgs ice) (Photo #2 Temp probe exposed)

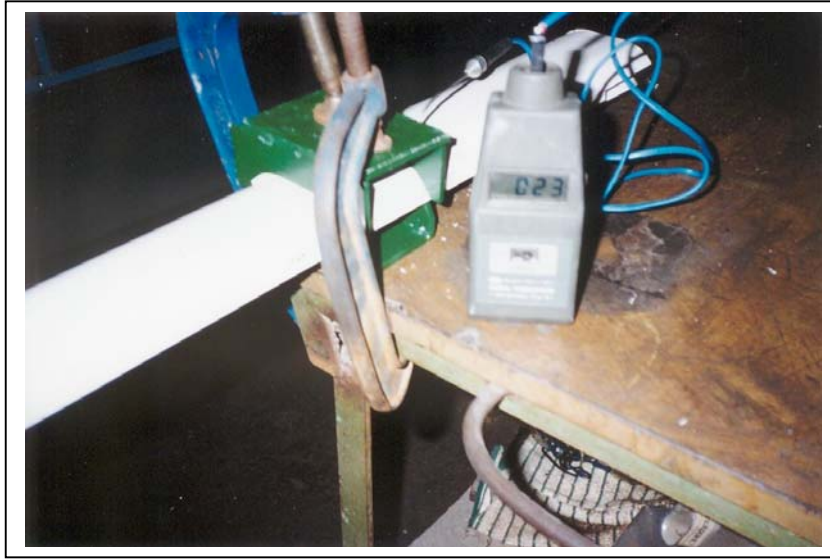
Photograph #3. Guide Post two-part anchor and G Clamps

Guidepost shaped two-part anchor unit (Photograph #3)

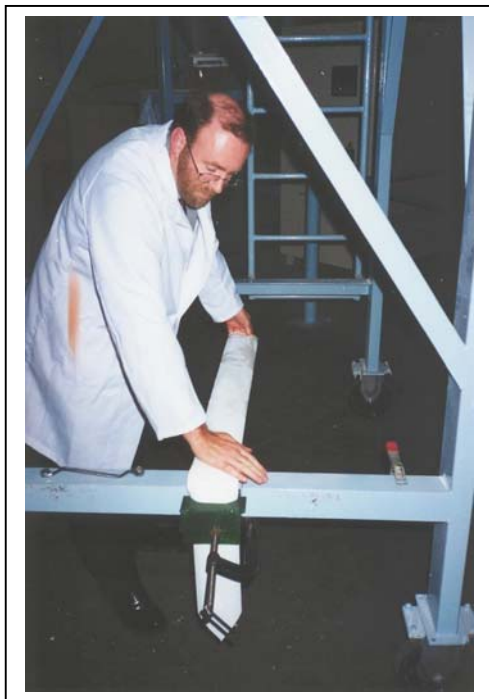
Photograph #4.
Vertical Mounting Frame

Steel vertical mounting frame (Photograph #4)

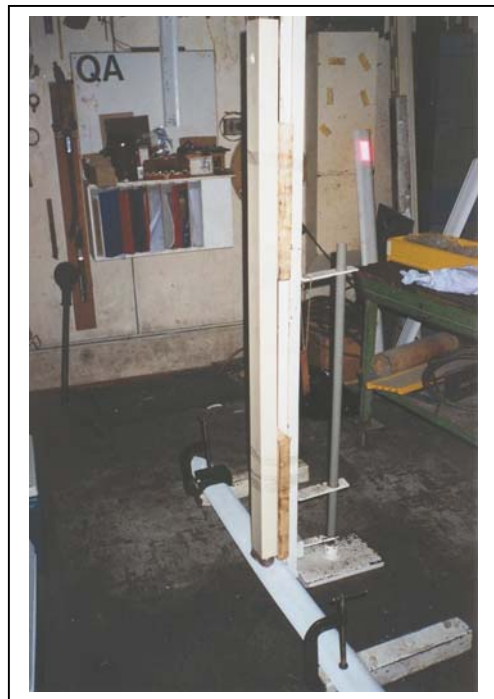
Photograph #5.
Impact resistance Testing Unit

Impact Resistance testing unit with 1500 mm low friction guide (Photo #5)
